approach

DECEMBER 1967

THE NAVAL AVIATION

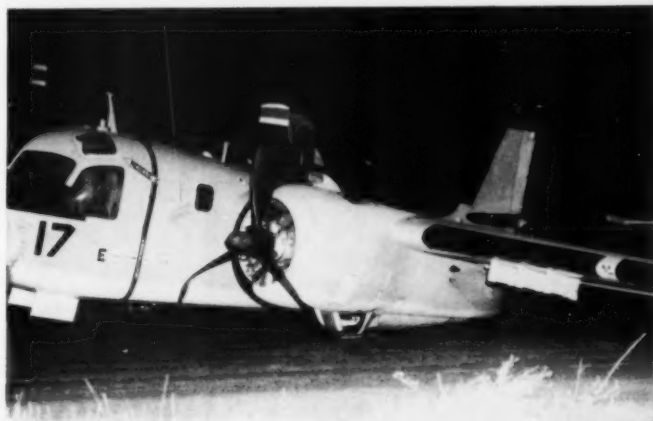
. . . to the port main landing gear.

After dumping fuel, an approach to a precautionary landing was commenced with the barber-pole still showing. With flaps set at $\frac{2}{3}$, initial touchdown was made on the starboard side of the runway to give more room for maneuvers to hold up the port wing as long as possible in case the MLG collapsed. At first, all was encouraging but after about 1500' of roll, the port MLG was felt to give way. Full aileron held up the wing for only a few seconds more. At the pilot's command, the copilot cut the mixtures and feathered the port prop. As the barely rotating prop began ticking the runway a left turn developed. Hard right brake momentarily kept the aircraft going straight and cleared the prop for a moment, but, ultimately, the S-2E swerved off the left side of the pavement and came to a stop on its port engine nacelle, starboard MLG, nose gear, and tail. The crew exited unscathed and no fire ensued.

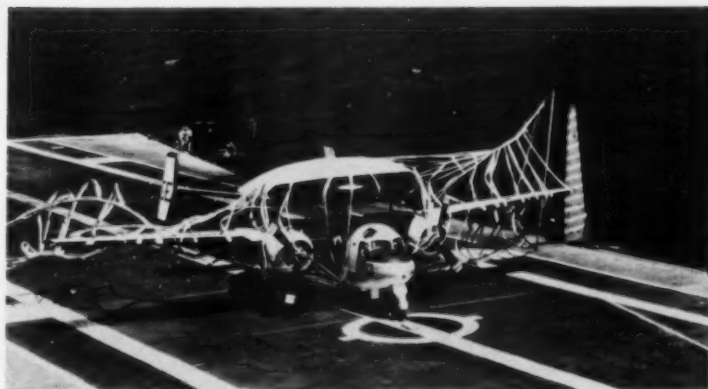
An E-1B takes the barricade.

The emergency arose when the tailhook of the *Fudd* snapped off on the pilot's first landing attempt. After the green shirts' quick work with the barricade, emergency fire and crash crews stood by as the pilot made his second pass. The aircraft touched down smoothly on centerline and rolled into the barricade (see photo). Damage to the aircraft was later classified as minor.

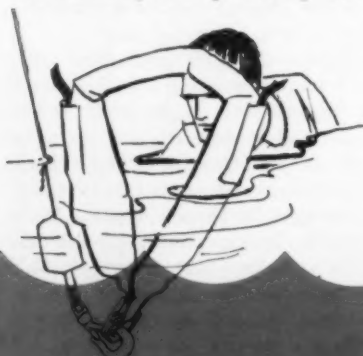
1. Approach sling from side opposite cable.

and Procedures Used in Helicopter Rescue Operations, shows step-by-step how to get into the rescue sling. In the accompanying drawings, personal survival equipment has been omitted for clarity.

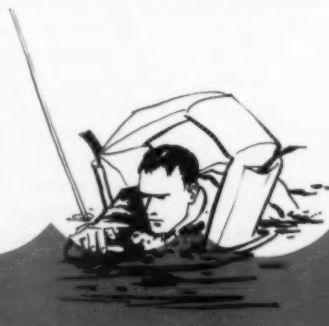
2. Extend arm through loop of sling.

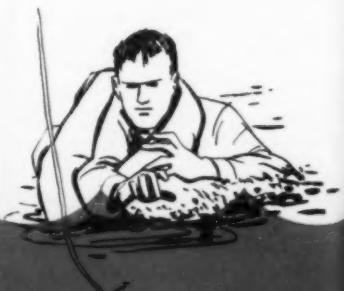
3. Slip sling over shoulder and head.

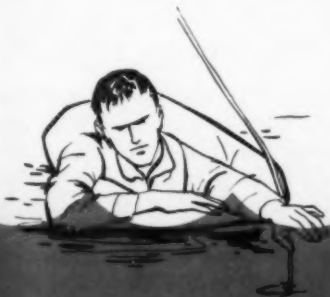
4. Put other arm into loop of sling and slip sling over other shoulder.

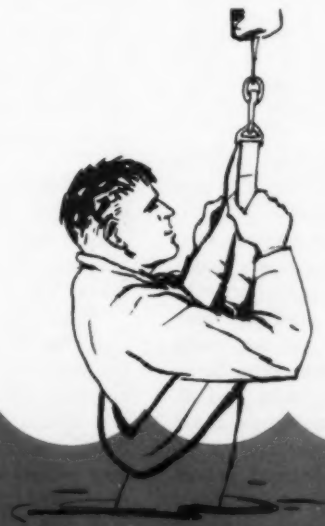
5. Position in sling after proper entrance prior to hoisting.

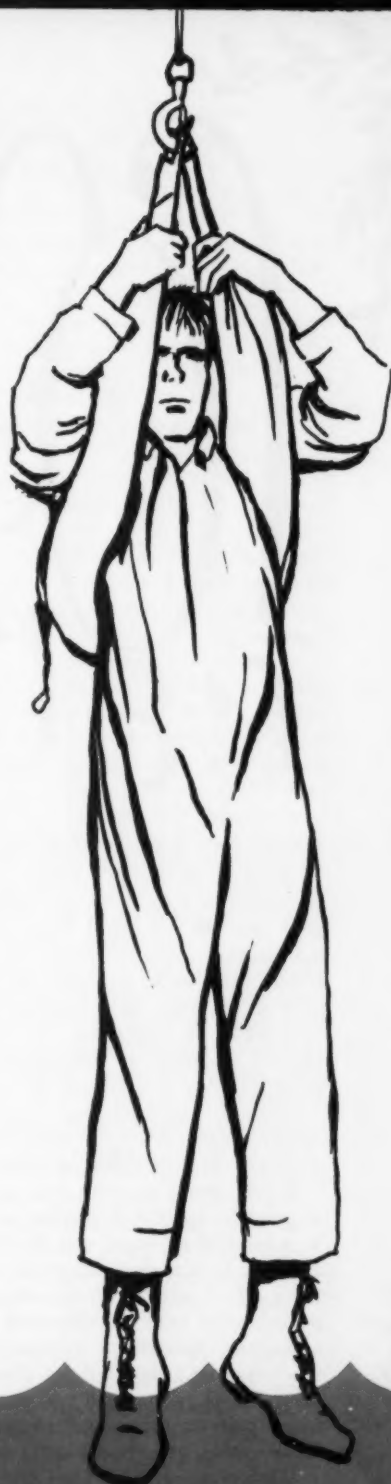
6. Hoist position in sling.

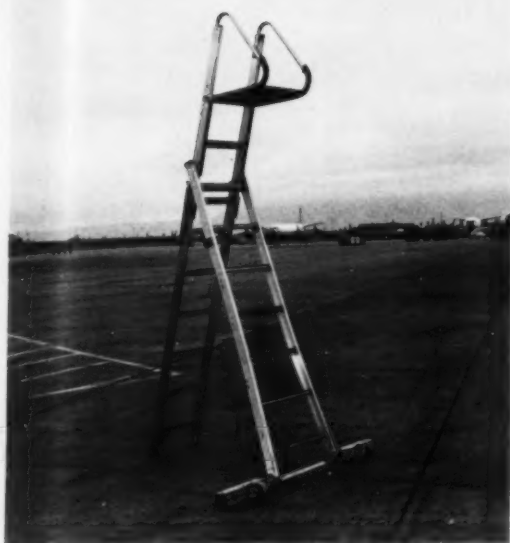
Ladder portability is improved by adding wheels.

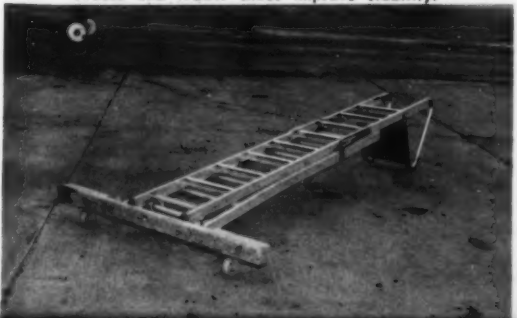
Braces and ladder shoes improve stability.

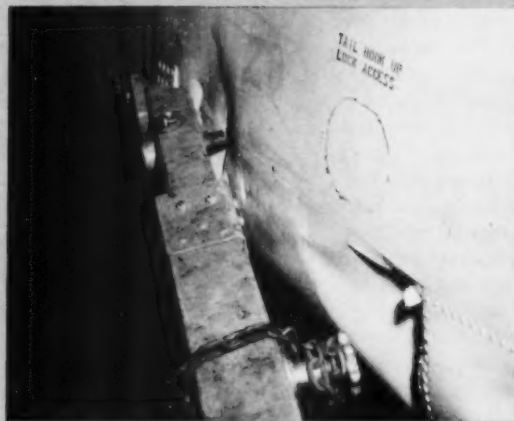
Steel against aluminum is hard on aircraft.

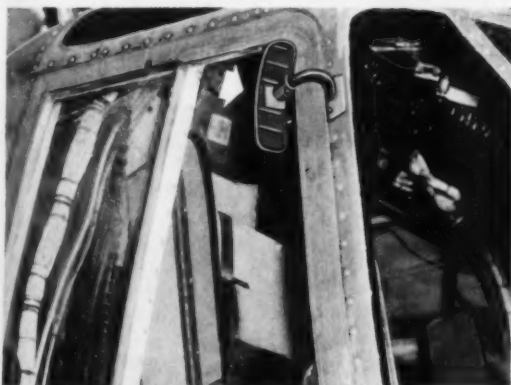
SEA KING gets mirrors—A flight safety and operations improvement item for pilot and copilot has been authorized by Airframe Change 197. The AFC, based on Sikorsky Drawings ECP 5370 was approved by ACCB 71-749 on 29 March 1967.

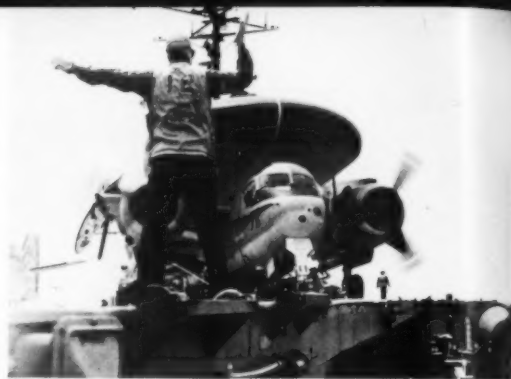
Hand Signal Gloves

Bright orange gloves worn by RANDOLPH'S yellow-jerseyed directors aid pilots in responding to director's hand signals, particularly during rain or reduced visibility.

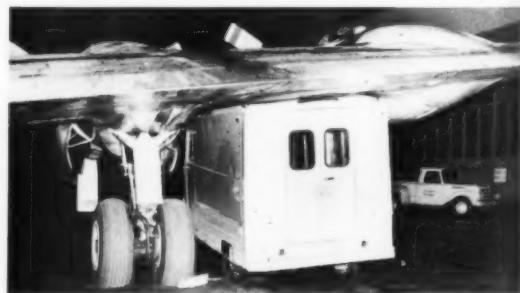
It Doesn't Fit—A van driven by unauthorized person(s) on the ramp area at night was aimed between No. 3 and 4 engines of a C-118. The end result—crunched aircraft, crunched van—a needless and irresponsible act that doesn't fit into any scheme of operations.

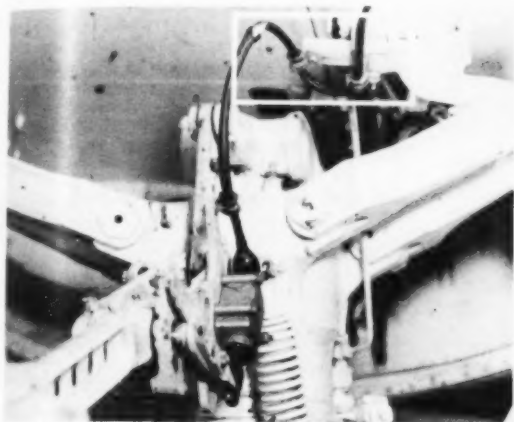
1. Electrical lead almost severed (inset) because of misrouting.

WHEN the pilot of a P-3 lowered the gear for a landing, the starboard main gear barber-poled. Upon recycling, the gear still indicated UNSAFE. He executed the NATOPS emergency checklist for unsafe gear indication including a tower fly-by and landed with the unlocked gear indication without incident.

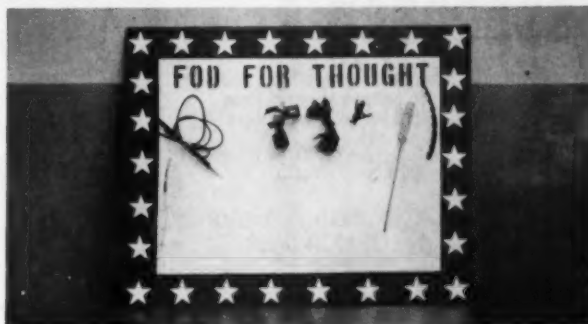
Found foreign objects generate "FOD for Thought."

Foreign objects found by pilots are posted on the board located in the line shack. In the short time the board has been in use it has given our program a shot in the arm in awareness and some participation.
